## Asbestos

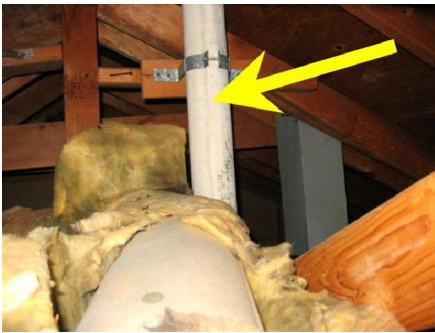
Figure 1. Possible asbestos insulation on furnace exhaust flue in attic.

Asbestos can also be found in some types of attic insulation and some types of ceiling acoustic tiles, as well as many other places depending on when the home was built. Another very common area where asbestos still exists in our homes is as insulation on exhaust flues on forced air furnaces (typically in the attic; see Figure 1) and water heaters (see Figure 2). Asbestos exhaust flue insulation, also called asbestos pipe wrap, is one of the more hazardous uses of asbestos because it is less stable than other forms of asbestos materials due to the heat from the exhaust flues. Generally it is safe to assume that insulated pipes contain some sort of asbestos pipe insulation material. Because asbestos pipe insulation is prone to deterioration, most authorities consider it a friable asbestos material and a health hazard.

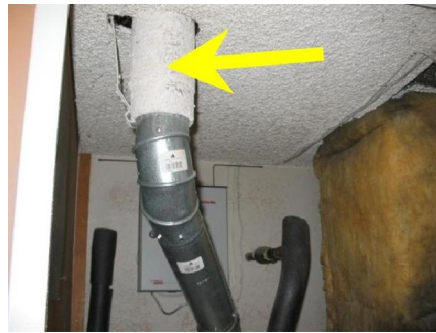
Figure 2. Possible asbestos insulation on water heater exhaust flue.
