# Efflorescence

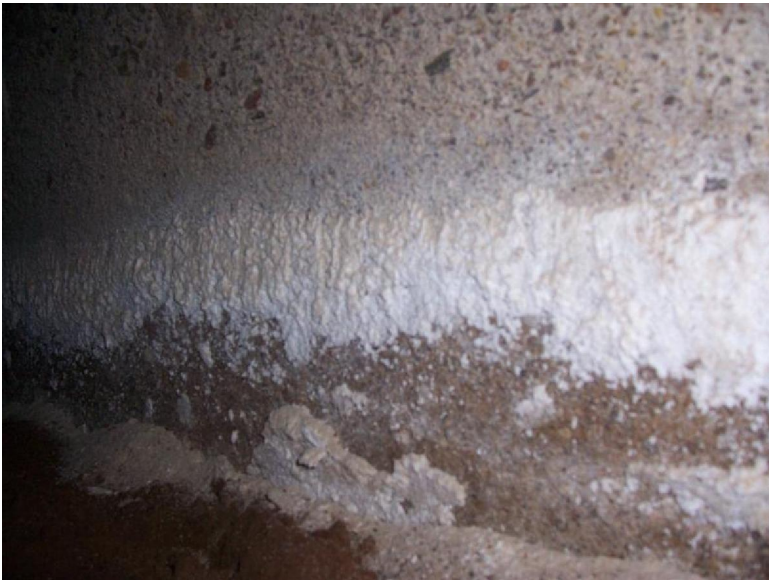
Figure 1. Excessive efflorescence on foundation wall.

Efflorescence (see Figure 1) is an accumulation of minerals deposited by water evaporating upon movement through various materials. It is commonly seen in concrete, brick, and stucco. While efflorescence in and of itself typically does not present a problem, an accumulation of efflorescence indicates that water is moving through the concrete, brick, or stucco, and damage or deterioration is the typical result.

Efflorescence also sometimes conceals cracks, particularly in foundations, retaining walls, and fences; concealed damage is not within the scope of the property inspection. Efflorescence in driveways, walkways, porches, patios, and decks typically indicate that water is ponding in those areas. Once efflorescence begins, it is very difficult to stop, and you'll simply have to practice
